NATIONAL TRANSPORTATION SAFETY BOARD

**SYSTEMS GROUP CHAIRMAN FACTUAL REPORT ADDENDUM FOR
ELECTRICAL SHORT CIRCUIT/ARCING OF AGED AIRCRAFT WIRING**

A. ACCIDENT: DCA96MA070

Report No. N191-RPT4AU99

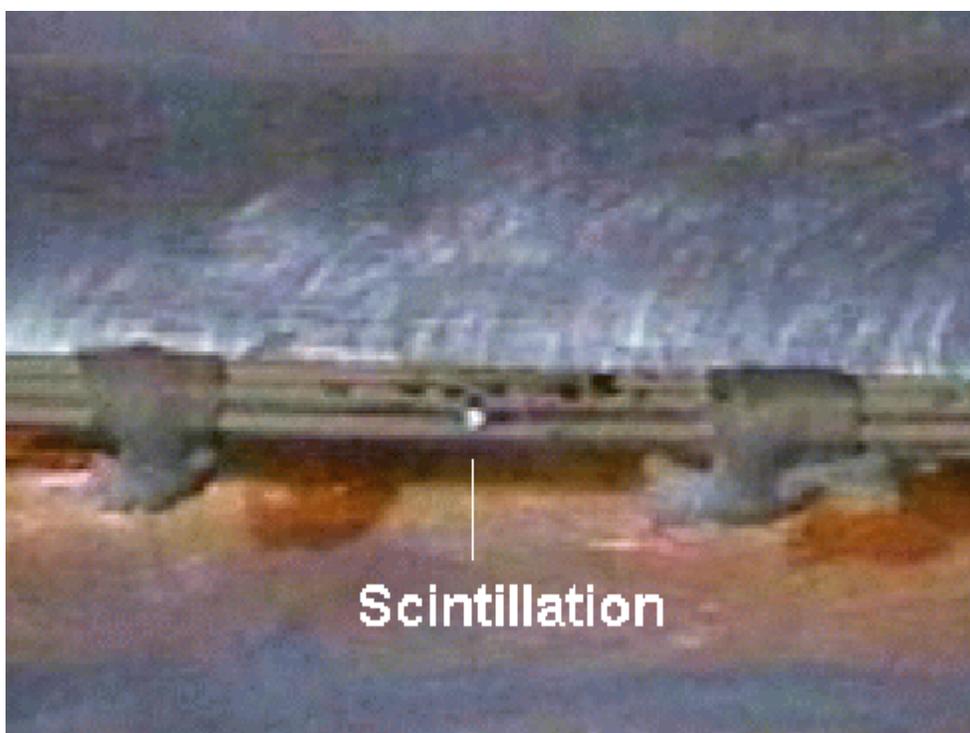
Figure 10. Scintillation at the edge of a pre-damaged crack.

Scintillations were the first electrical activity that was observed during the experiments. Visually, they began as pinpoints of light that flickered at the edge of the pre-damaged cracks in the insulation (Figure 10). As time went on and a char track built up on the insulation, the flickers of light appeared at various places along the path between the pre-damaged cracks. During the more lively scintillations an electrical buzzing or crackling sounds could be heard. No scintillations caused a circuit breaker to disrupt power.

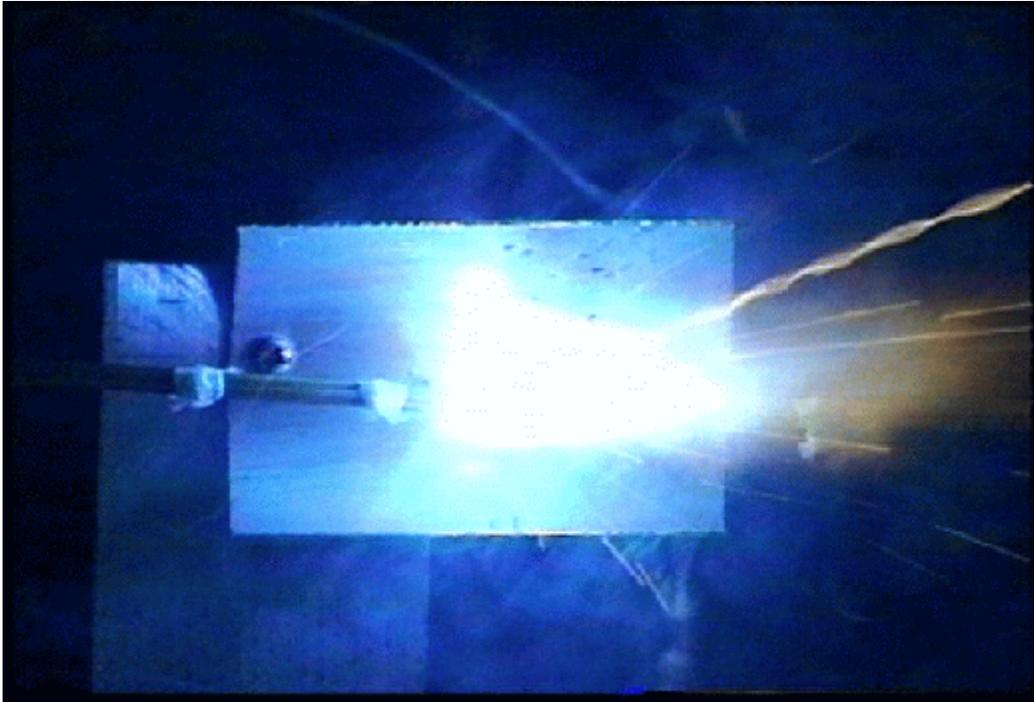
Figure 15. Example of a strong arcing event.

Strong Arcing events were characterized by an active bright flash or glow that continued for a up to a second or more (Figure 15) with an intense electrical hum or crackling. The arc can cause much collateral damage to the insulation of adjacent wires, some of which became involved in the event. Strong arcing was often terminated with tripping of the circuit breaker.

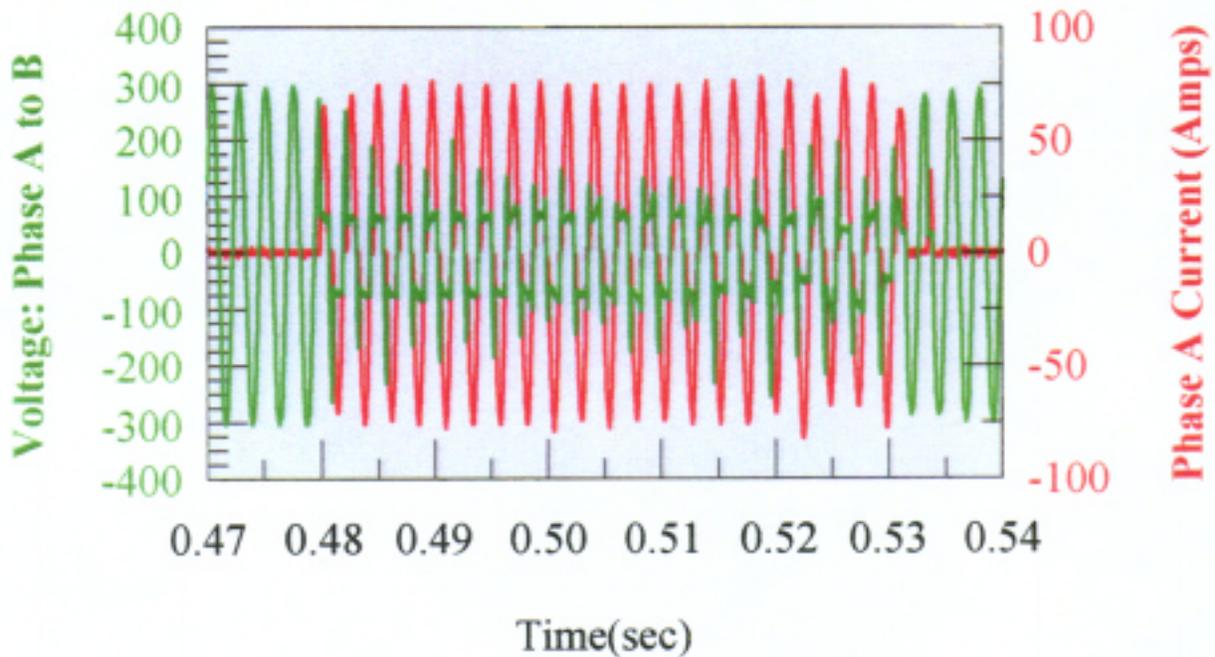
Figure 19. Preliminary Test B: Oscillogram of current during intense flashing event.

The bundle in test B experienced a period of intense activity within the first 30 seconds approaching strong arcing with 20+ cycles of continuous arcing (Figure 19). This period included current peaks of 75 Amperes and over 350 joules of electrical energy was dissipated in the event. The sample was then removed and examined. There was about a 1/4 inch of damage and char build up around the cut in the insulation, but both conductors were still intact.

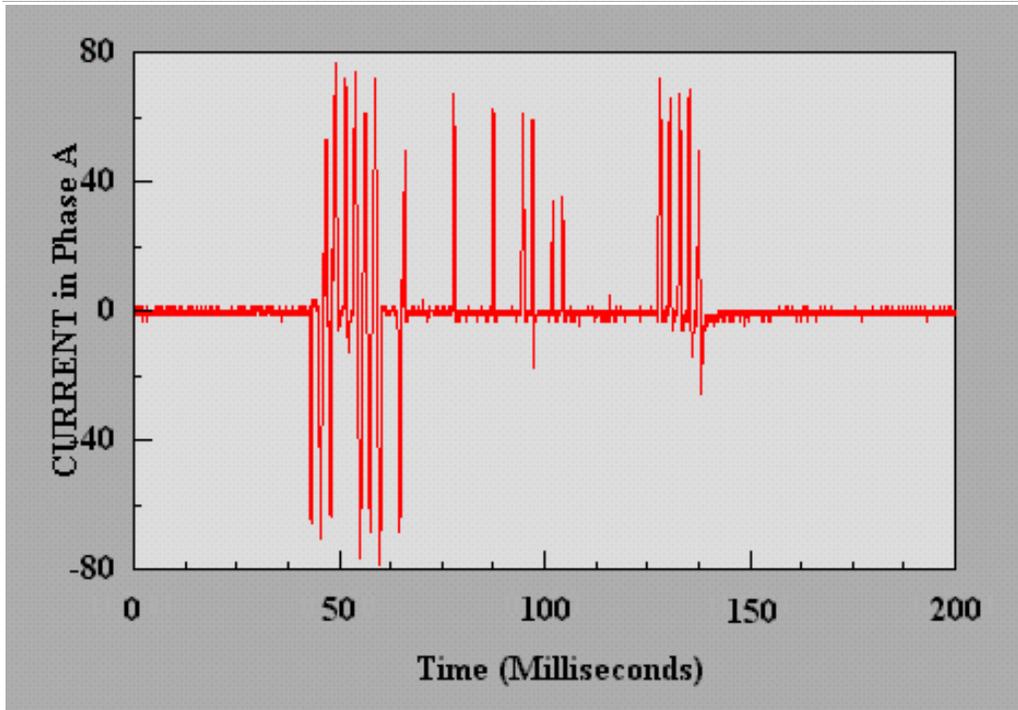
Figure 22. Test 1: Oscillogram showing intermittent current during a flashing event.

Looking at the oscillograms taken during the more active times of the test, we see that several of the flashing events lasted for 5 to 10 cycles. An example of this is shown in Figure 22 which shows the current in one of the three phases during Test 1. The sequence begins with 8 cycle consecutive cycles having high current for at least one of the 1/2 cycles and some times both of the 1/2 cycles. This is followed by a period intermittent cycles of high current lasting for 50 milliseconds followed by another 5 cycles that had continuous arcing currents. Not shown in Figure 22, but recorded on the oscilloscope, is that there were no high current cycles for the next 4 seconds (corresponding to more than a 1000 cycles).

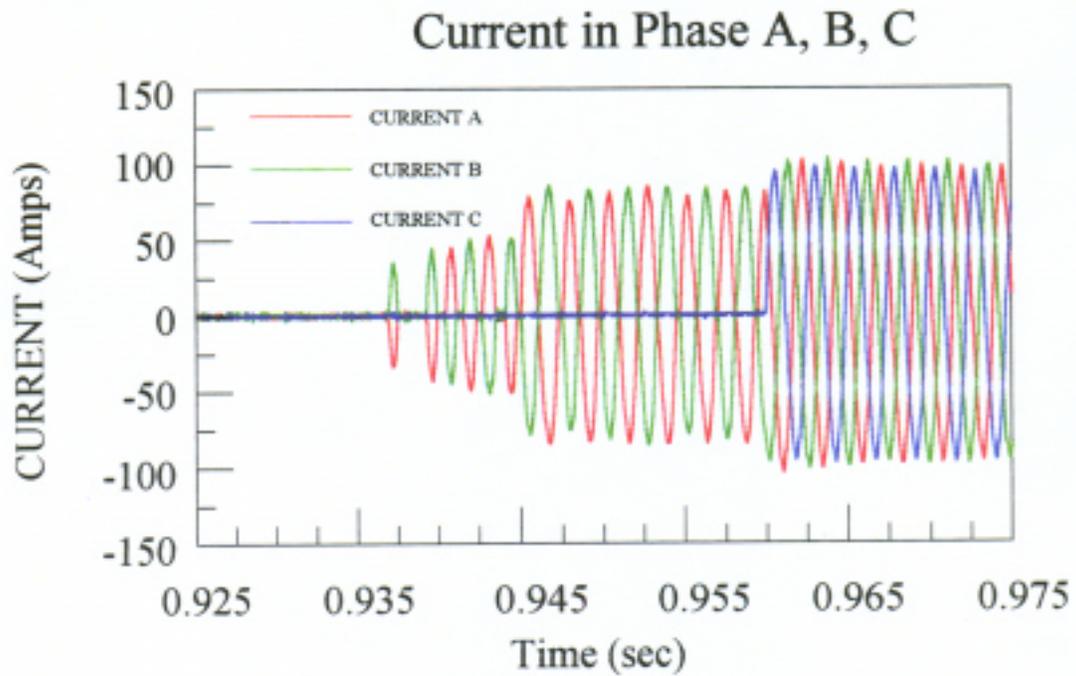
Figure 25. Test 3: Oscillogram of three phase current during arcing event.

A look at the oscilloscope recording of the first burst of strong arcing shows that the event lasted for less than 1/4 of a second and that all three phases became involved within 30 milliseconds (Figure 25). There were many current peaks greater than 100 amperes during the arc. Estimates of the electrical energy dissipated in the two events before the circuit breaker tripped is about 2 kilojoules. The second burst of arcing that resulted in the tripping of the circuit breaker was not recorded because the data from the first arcing was in the process of being stored to disk at that time.

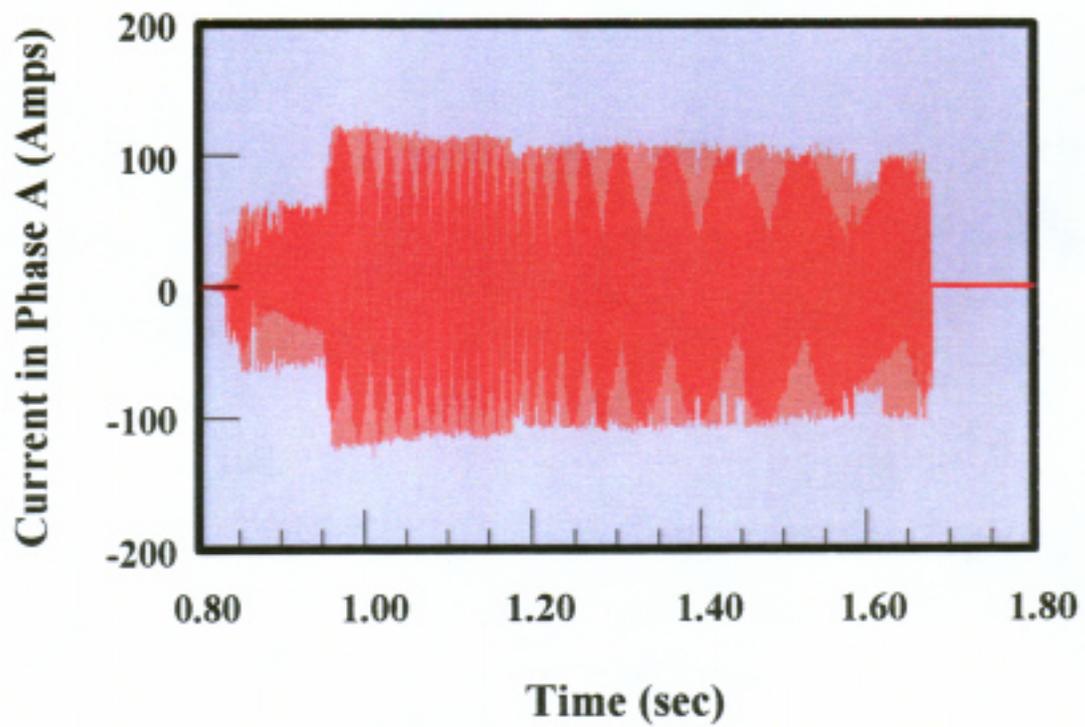
Figure 28. Test 4: Oscillogram of phase A current during a strong arcing event.

The oscillogram from the initial arcing in Test 4 indicates that the event lasted about 3/4 of a second and had current peaks of 125 amperes (Figure 28). The power is estimated to have been 8 kilojoules. The arcing in Test 5 lasted a little under 1 second.

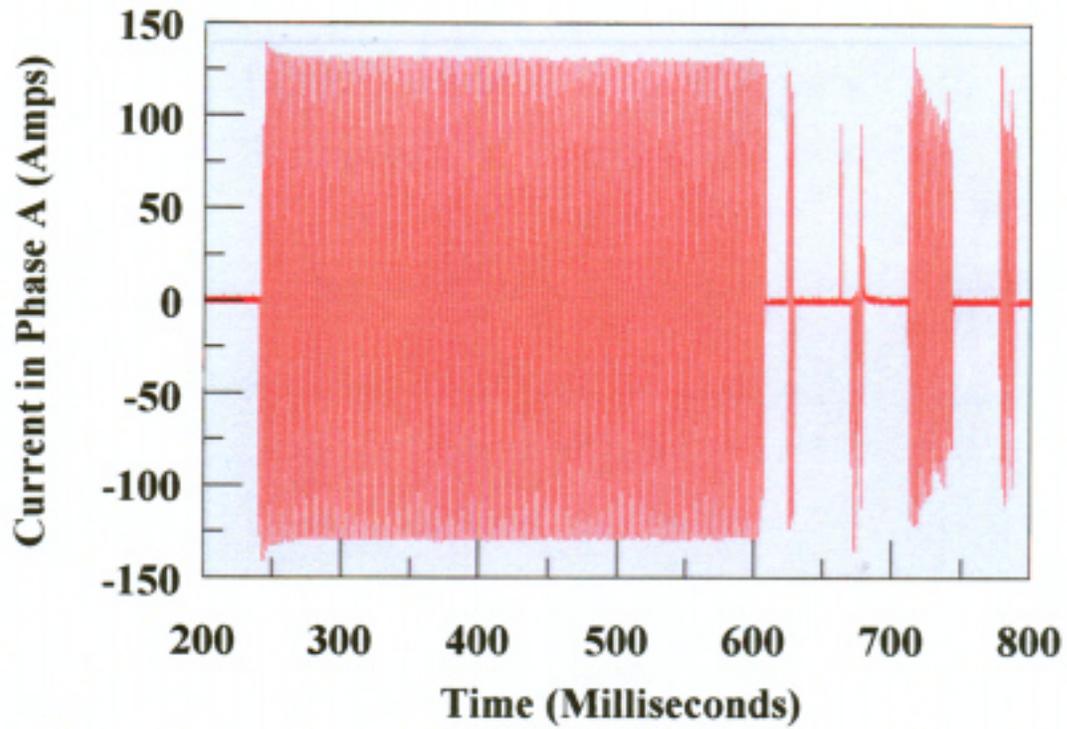
Figure 33. Test 9: Oscillogram of short circuit current that turns into intermittent arcing.

The circuit was then changed so that the A1 and A2 circuit breakers were put in parallel as was the B1 and B2 circuit breakers. This effectively increased the circuit breakers in series with the pre-damaged wire from 7.5 to 15 amperes. It also decreases the circuit resistance to 0.5 Ω in series with the sample. When the power was applied there was 350 millisecond with a 125 amp peak short circuit current followed by intermittent flash type events for 200 milliseconds (Figure 33). This caused physical damage to the wire insulation and deposited black soot for about 3/4" surrounding the pre-damaged area. The oscillogram indicates that the C phase wire (previously undamaged) became involved in the arc with current peaks of 100 Amperes. None of the circuit breakers tripped. All 5 of the non pre-damaged wires failed the wet dielectric test indicating substantial damage to the insulation.

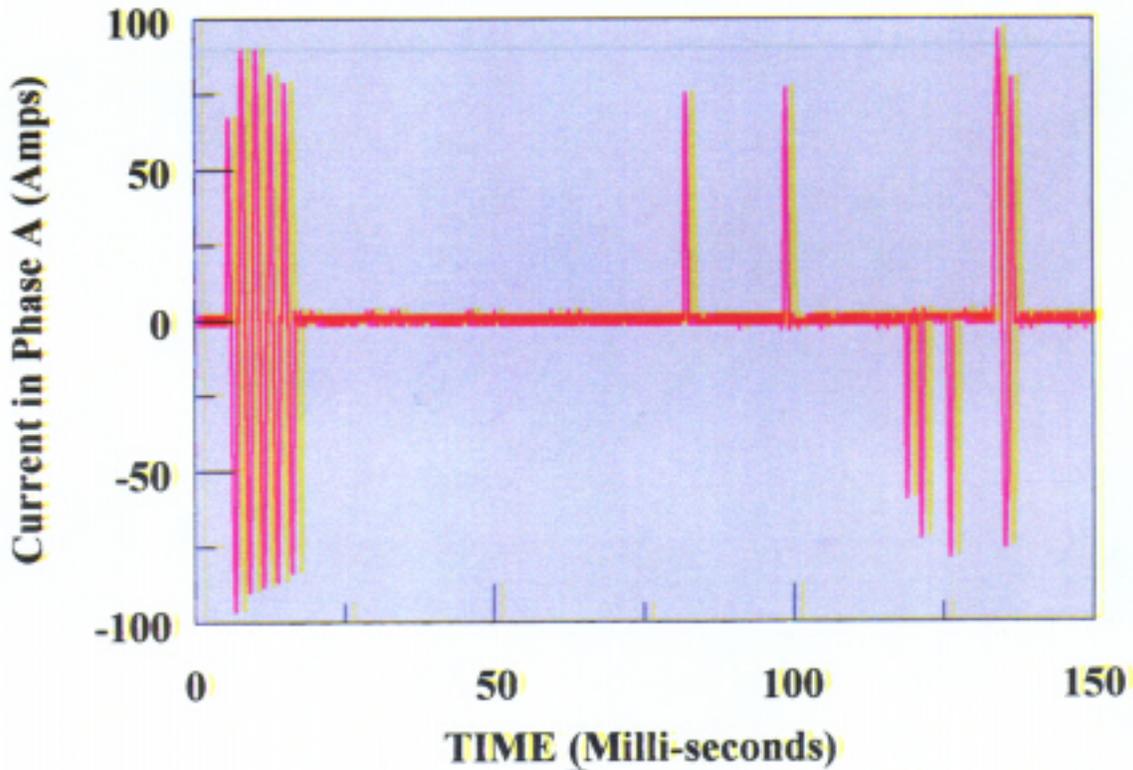
Figure 36. Test 12: Oscillogram of intermittent current during a flash event.

The oscillograph showed the there was sporadic arcing waveform with current peaks reaching 80 amperes for 150 milliseconds (Figure 36). Near the end of this period the C phase wire became involved in the arcing.

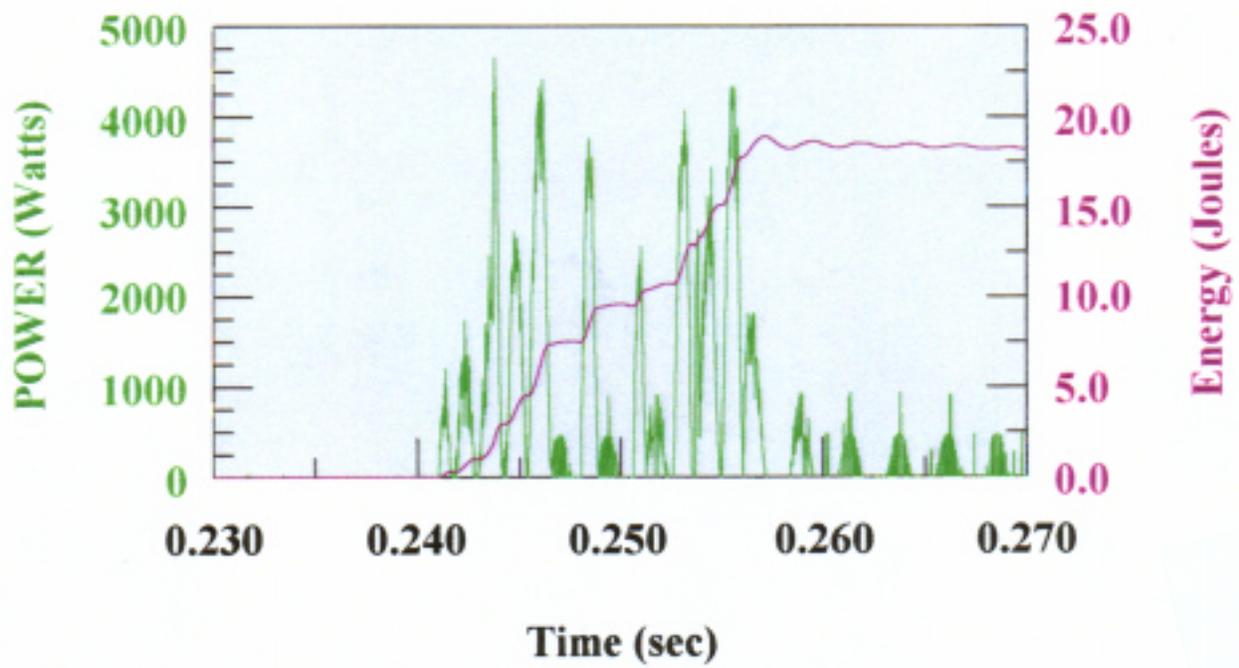
Figure 37. Test 14: Electrical power and energy dissipated during a flash event.

The oscillogram shows that there was intermittent arcing for less than 20 milliseconds and that the phase C wire did not become involved. There were peak current of 100 amperes and the total energy dissipated was about 18 joules. Figure 37 shows the power and energy dissipated during the flash.

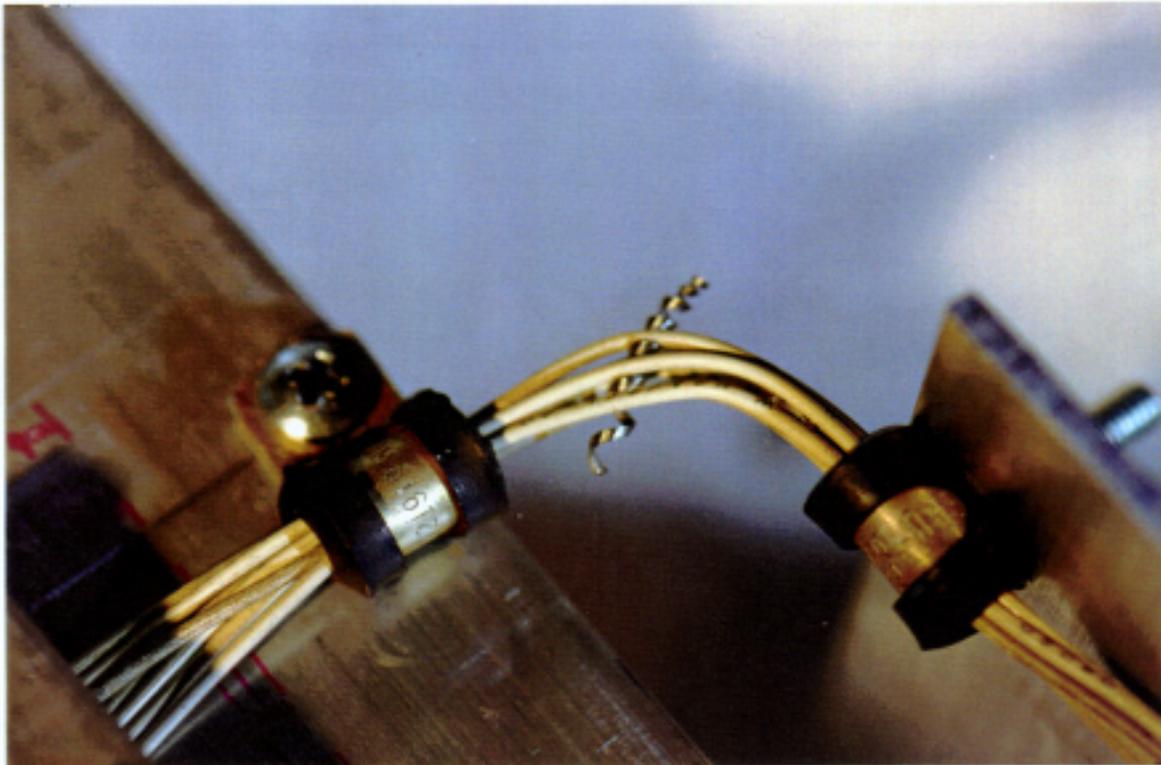
Figure 38. Test 16 A: Sample during the metal shaving abrader test 90° (right angle).

In this test two samples were run concurrently. Bundles were identical to each other except that bundle A had a steel shaving woven between its wires and bundle B had an aluminum 7075 shaving. The test was run for 19 1/4 hours with no arcing events (Figure 38). While the wire sustained some damage in the area of the shaving, the damage was primarily to the topcoat with the steel shaving doing moderate damage to the Poly X layer (Figure 39).

The flexing of the bundles did cause more severe damage in areas away from the shaving. In test A, one of the wire was broken completely in half. In test B, one wire was broken in half and the insulation on other wire cracked so that the conductor was exposed. These three wires failed the wet dielectric test while all of the other wires passed.
